**CASCADE - WARM LAKE**  
**Terracon Project No. 62005055A**  
**PHOTO LOG**

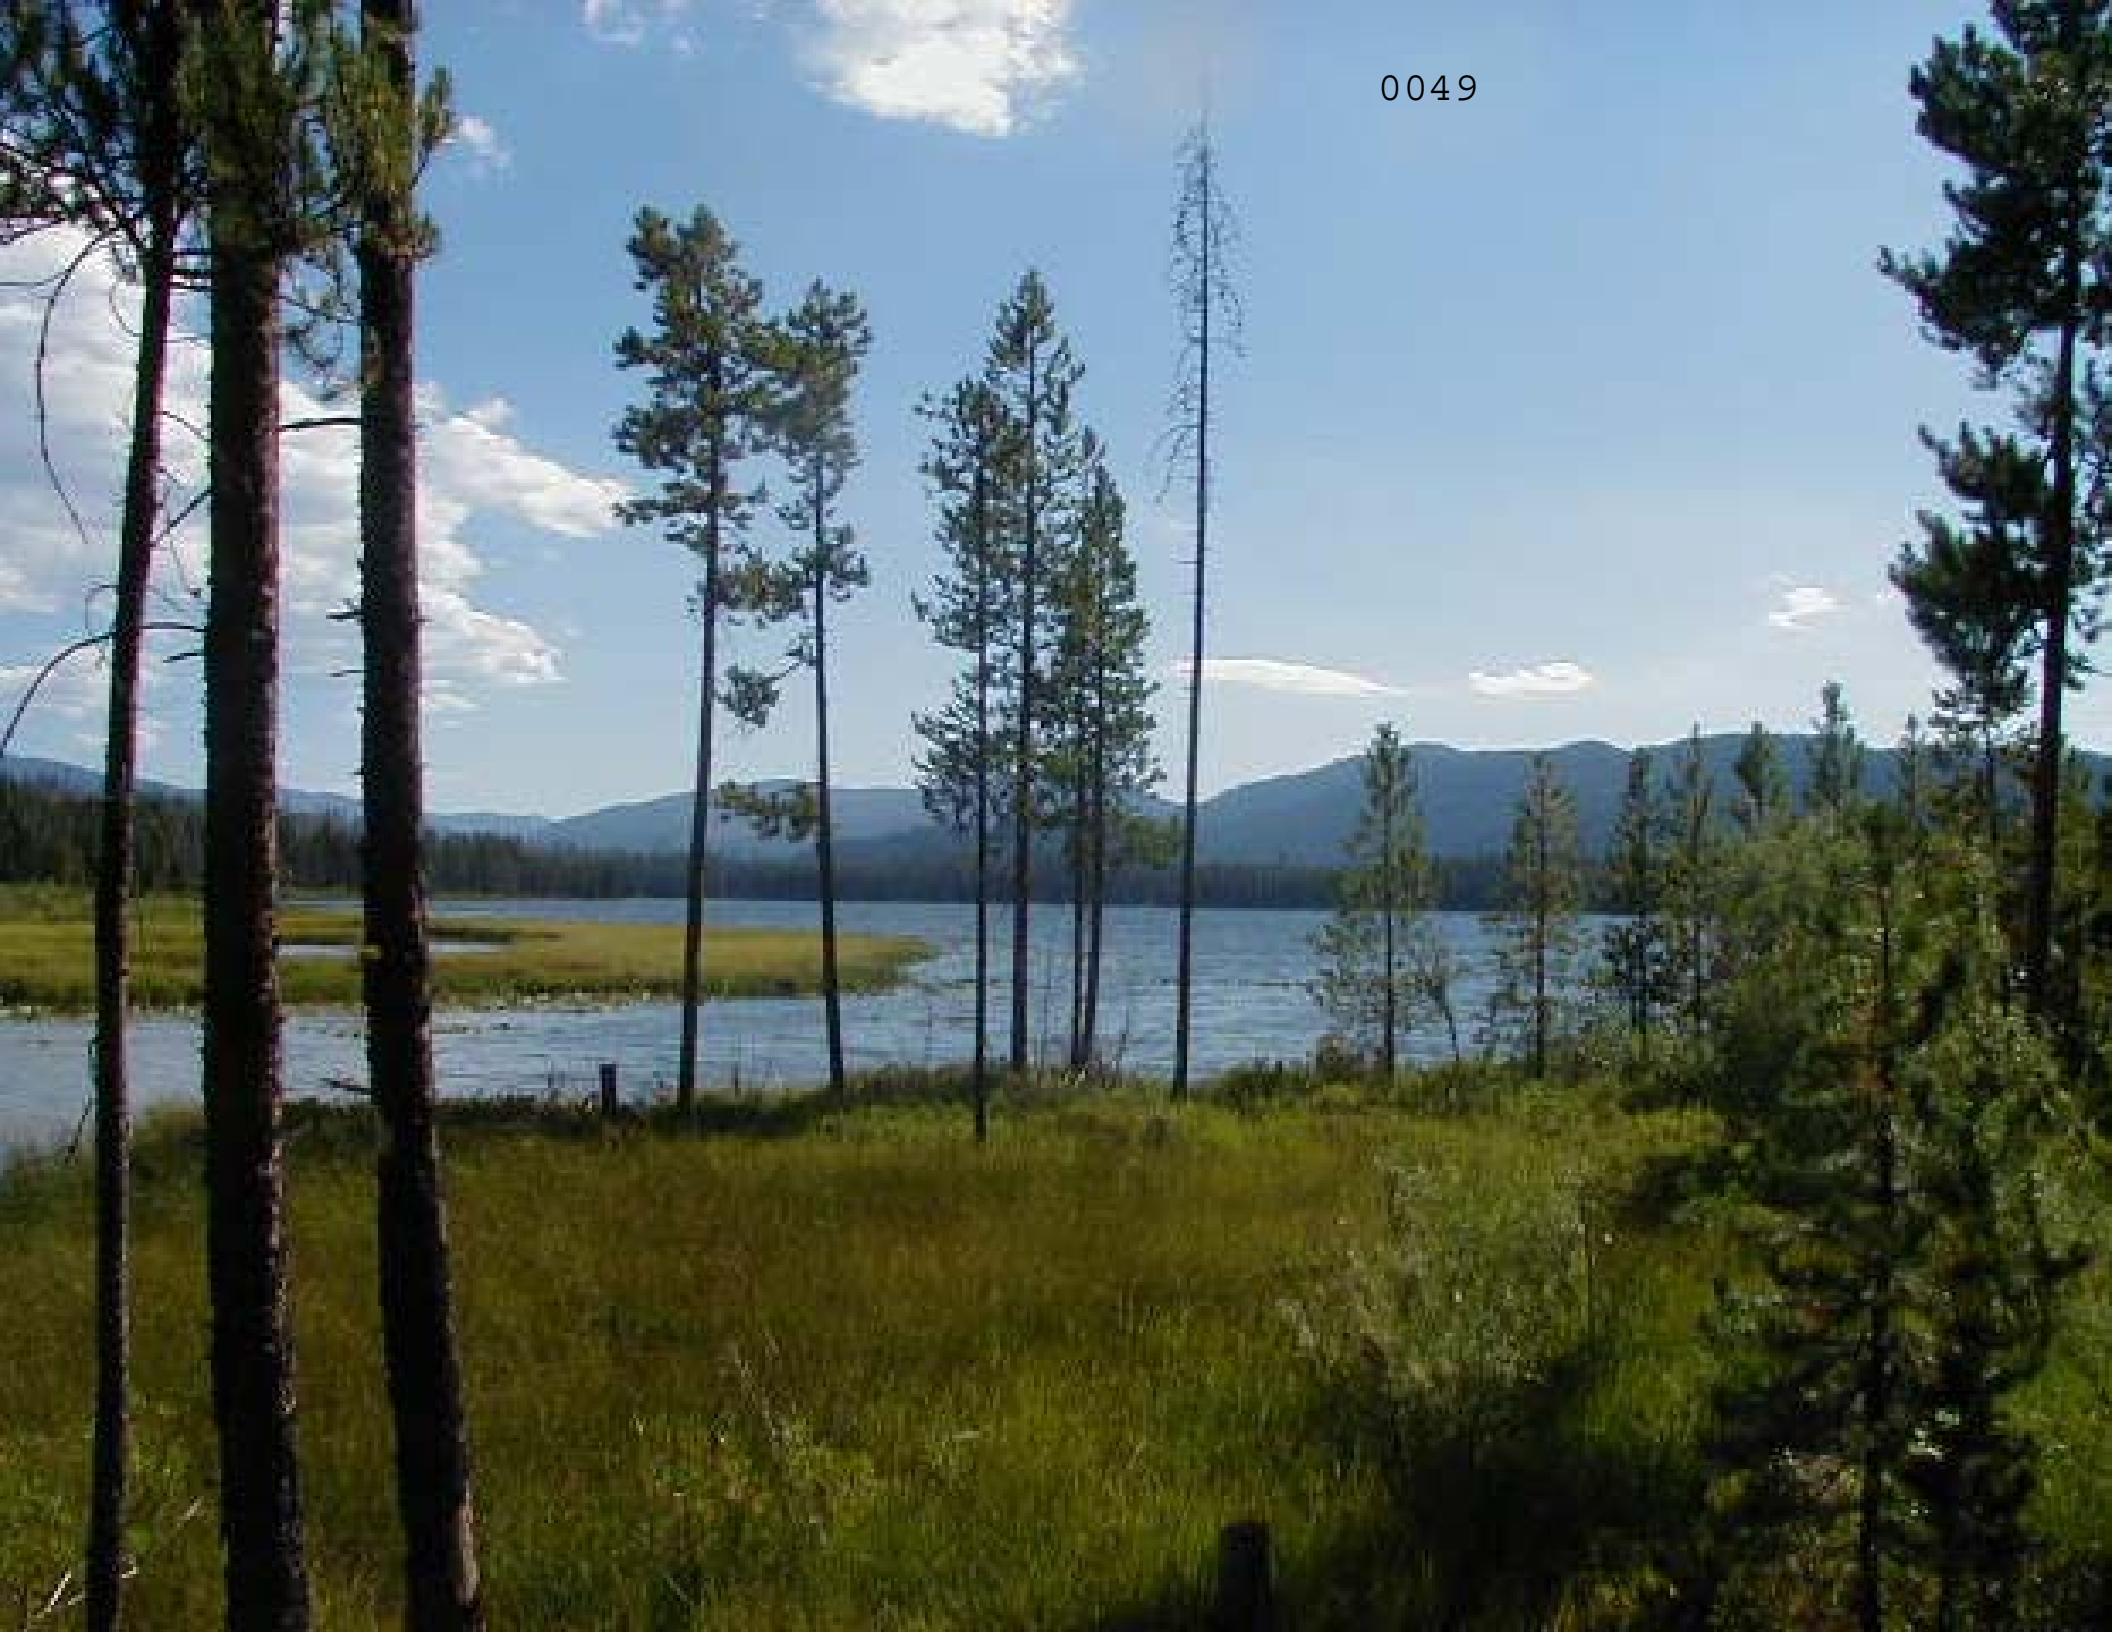
0047	26.2	Bleeding chip seal
0048	27.5	Bleeding chip seal near Firefighter Memorial Trail
0049	N/R	Warm Lake
0050	21.7	FH-20; patched, rutted, cracked, EB lane
0051	N/R	WB view of bleeding surface (west of beginning of project)
